RECONNAISSANCE REPORT ON GEOTECHNICAL AND GEOLOGICAL ASPECTS OF THE 14-16 APRIL 2016 KUMAMOTO EARTHQUAKES, JAPAN

Gabriele Chiaro¹, Gavin Alexander², Pathmanathan Brabhaharan³, Christopher Massey⁴, Junichi Koseki⁵, Suguru Yamada⁶ and Yudai Aoyagi⁷

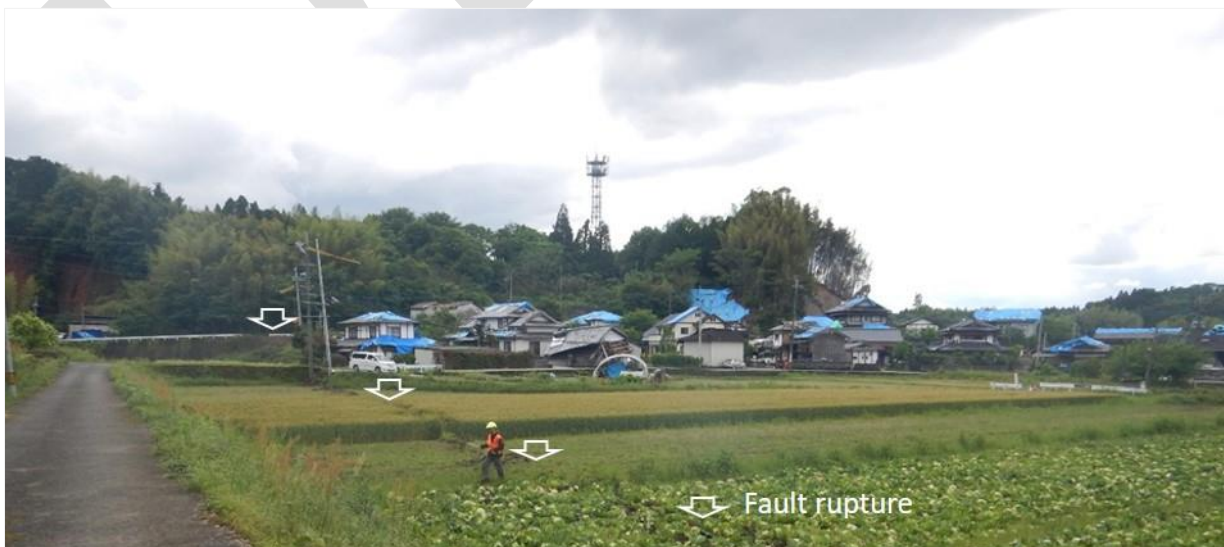
The most common form of damage was to the tiled roofs of residential houses and buildings. Such damage extended further out from the immediate epicentral area. In many locations, blue plastic sheets had been used to cover damaged roofs, and were a common sight across the area, see Photo 1.

Photo 1: Typical blue sheets covering damaged roofs in close proximity to the surface fault rupture (Location 22 in Figure 2: N 32.80487; E 131.8593)

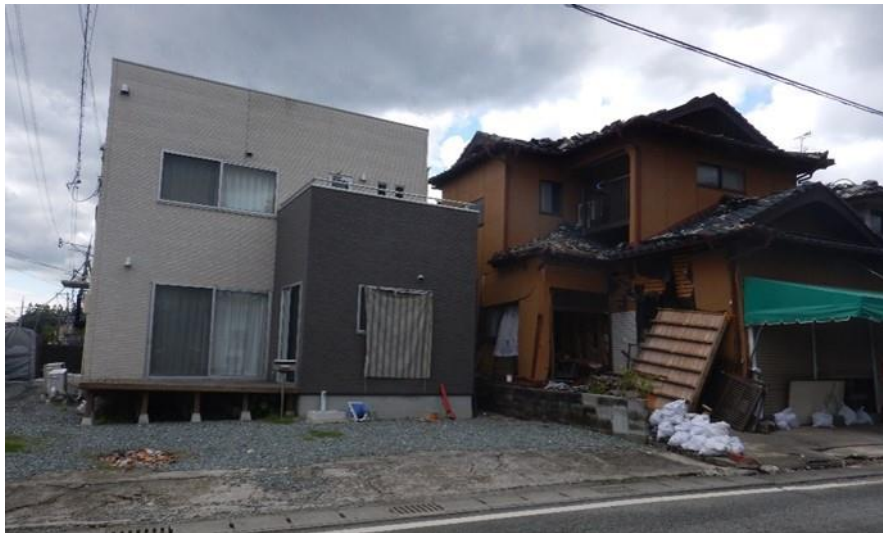
Most of the buildings appeared to have collapsed due to the strong ground shaking caused by the action of the inertia forces on the heavy roofs (Photo 2). Collapsed buildings were mostly old wooden one- and two-storey houses. The roofs of these houses were typically formed from “*kawara*” tiles, which were intentionally made to be heavy, in order to prevent them from “flying away” during typhoons. The Kumamoto district is one of worst typhoon disaster areas in Japan. It is also possible that deterioration of the structural members could have occurred as a result of insect damage.

Observations indicate that the lack of adequate bracing had contributed to this damage, as the houses appeared to have collapsed from rocking of the building during strong ground shaking. More modern houses appear to have been damaged and collapsed due to the presence of soft storeys, with garages in the lower storey.

Photo 2: Low damage to a new residential house (without tiled roof) and severe damage to two-storey timber house (with heavy tiled roof) observed in Mashiki Town (N 32.7876; E 130.8185)

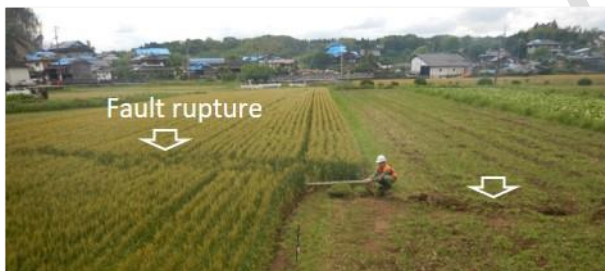
Photo 3: Fault rupture of 1.8 m lateral displacements observed in rice fields in Mashiki Town (location 22 in Figure 2: N 32.80487; E 130.8593)

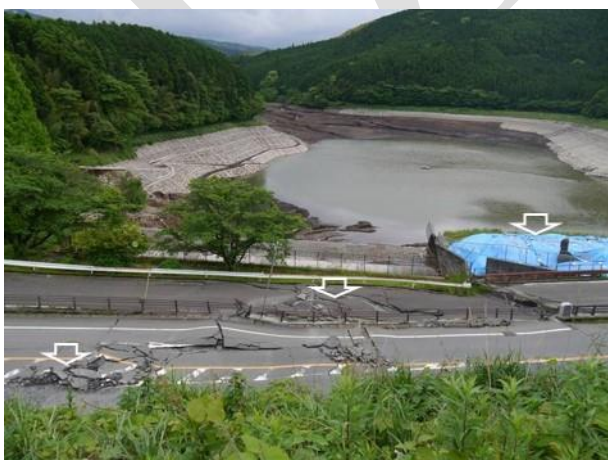
Photo 4: Surface fault rupture at the Ookirihata earth dam in Nishihara Village (Location 23 in Figure 2: N 32.8415; E 130.9321).

In Nishihara Village severe damage to the left hand side wall of the spillway of the Ookirihata earth dam and adjacent highway over dam crest were observed (Photo 4). No other damage was apparent to the team on the earth dam, but the dam has been drawn down following the earthquake. The GEER team [15] investigated this dam in detail and identified additional fault related damage.

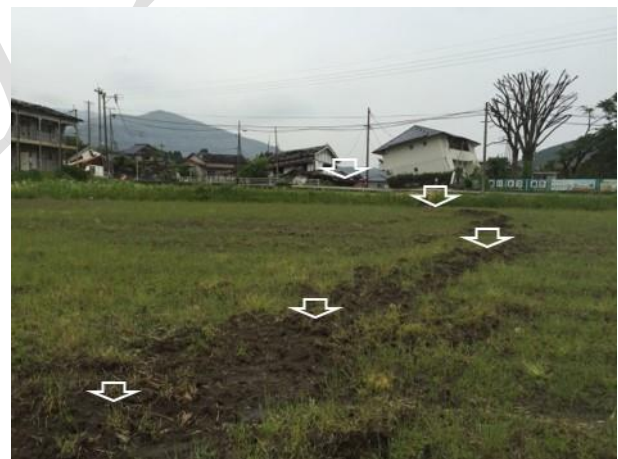
In Minami Aso severe damage and collapse of houses adjacent to the fault trace was observed (Photo 5). Fault displacement of less than 0.5 m was noticed in the rice fields adjacent to housing area.

Photo 5: Collapsed apartment block located on the fault rupture in Kurokawa, Minami Aso Village (Location 17 in Figure 2: N 32.8852; E 130.9943).

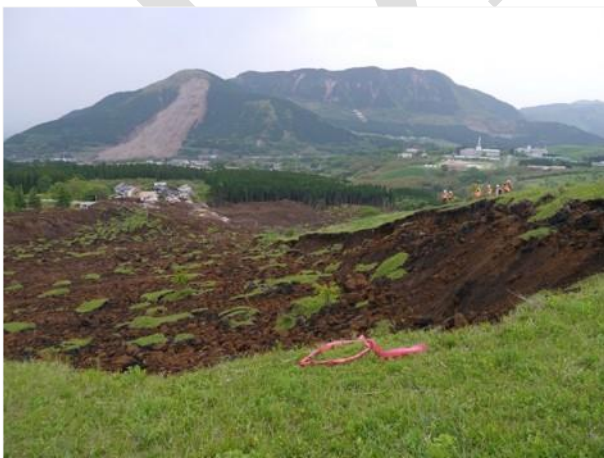
Photo 6: Source of earth flow/slide in Minami Aso Village (looking downhill), with damaged houses and the large debris avalanche at Aso Ohashi Bridge visible in the distance (Location 9 in Figure 2: N 32.8851; E 131.0049)

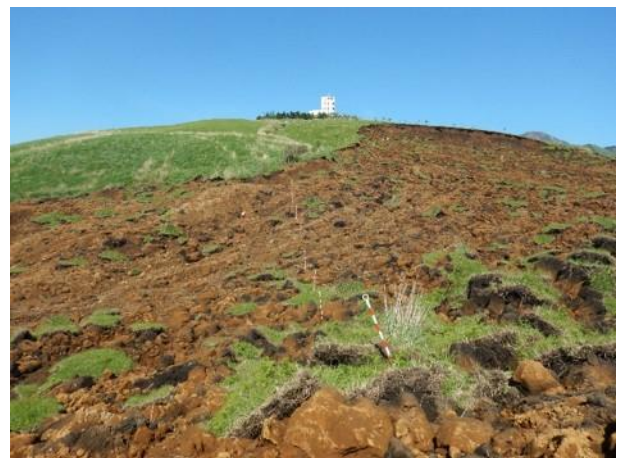
Photo 7: View of the main landslide (looking uphill), with the Aso Volcanological Laboratory visible in the distance (Location 9 in Figure 2: N 32.8951; E 131.0135)

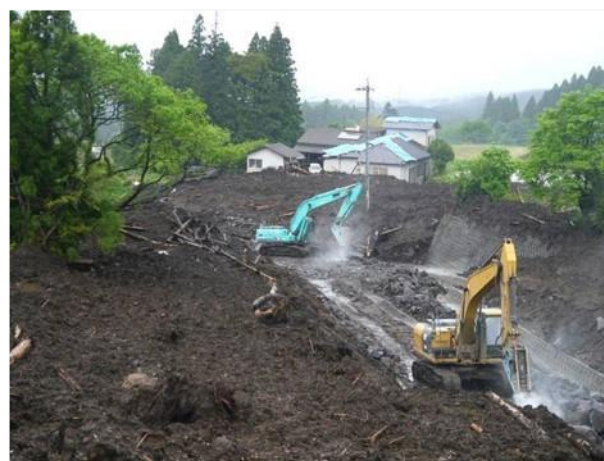
Photo 9: Debris-flow deposits being cleared up (Location 13 in Figure 2: N 32.8643; E 131.0216)

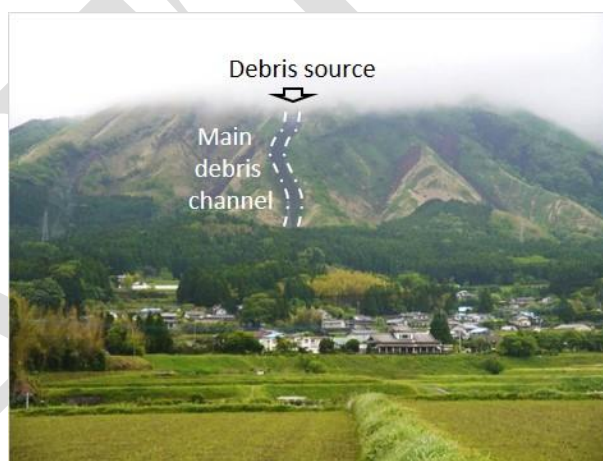
Photo 10: Debris flows sourced from the steep volcanic slopes above Kawayo, Minami Aso Village

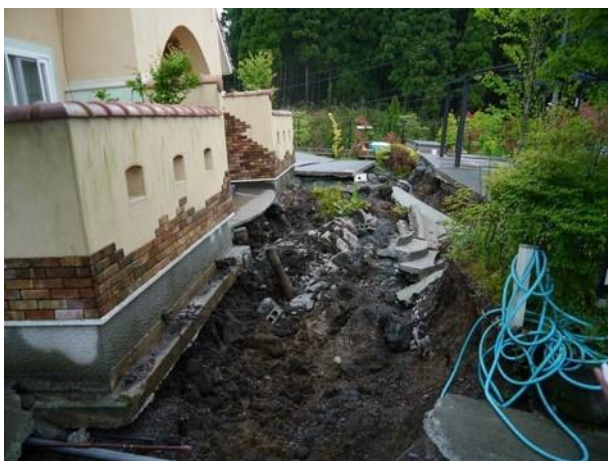
Photo 11: Translational slide / slump at Tokyu Country Town, Aso. About 40 houses were affected by landslide movement (N 32.8796; E 131.0030).

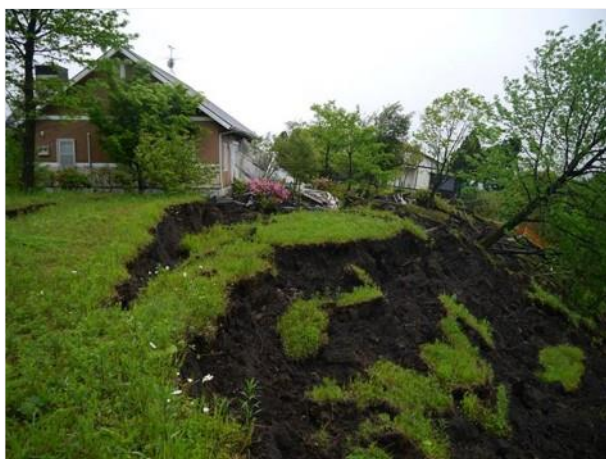
Photo 12: Toe area of the translational slide/slump at Tokyu Country Town showing the transition from sliding to slumping towards stream (N 32.8805; E 131.0025).

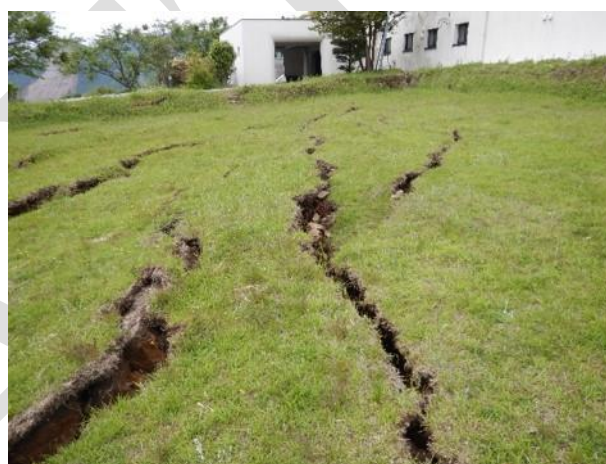
Photo 13: Extensive cracking located upslope near the Aso Volcanological Laboratory (N 32.8857; E 131.0069)

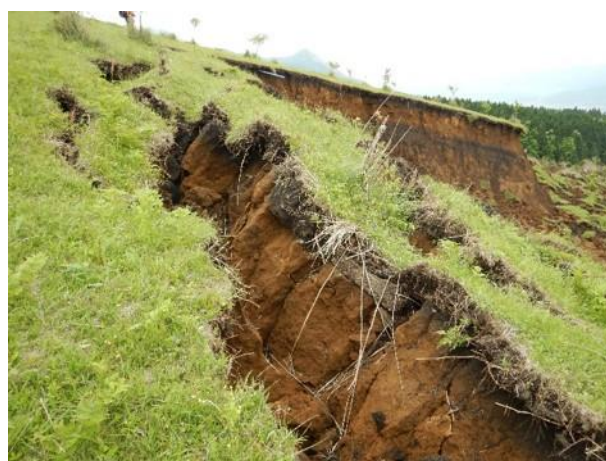
Photo 14: A typical cracking located near the scarp of the translational slide/slump below the Aso Volcanological Laboratory (N 32.8851; E 131.0050)

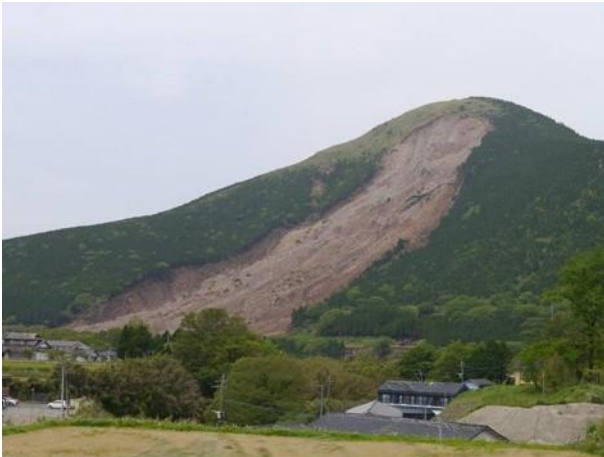
Photo 15: Debris avalanche at Aso Ohashi Bridge (Location 10 in Figure 2: N 32.8834; E 130.9896)

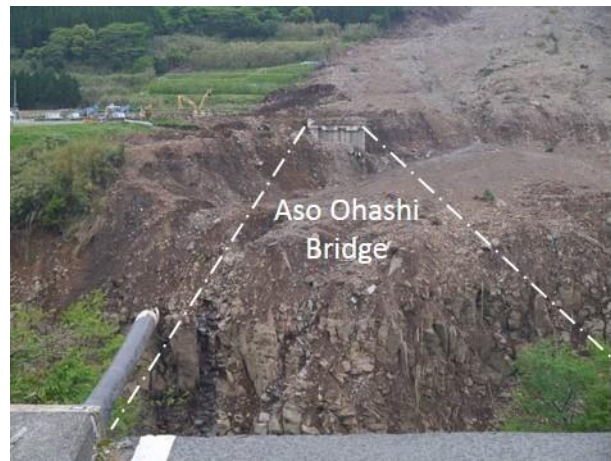
Photo 16: Toe of the debris avalanche at Aso Ohashi Bridge. Note the bridge has been destroyed by the landslide (Location 10 in Figure 2: N 32.8834; E 130.9896).

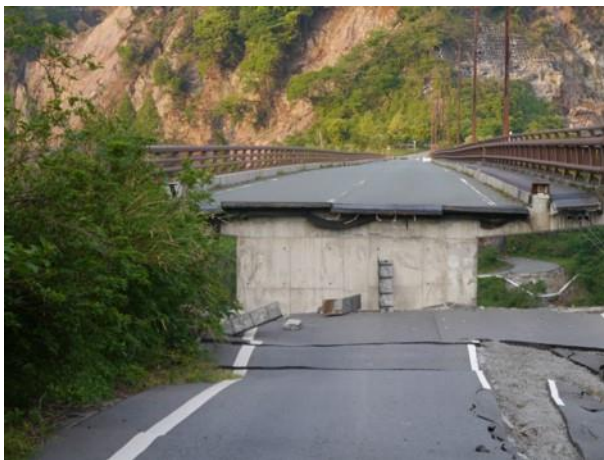
Photo 18: Displacement of the road bridge abutment. The displacement resulted from loosening and toppling of the jointed rock mass supporting the abutment foundation (N 32.8764; E 131.9827).

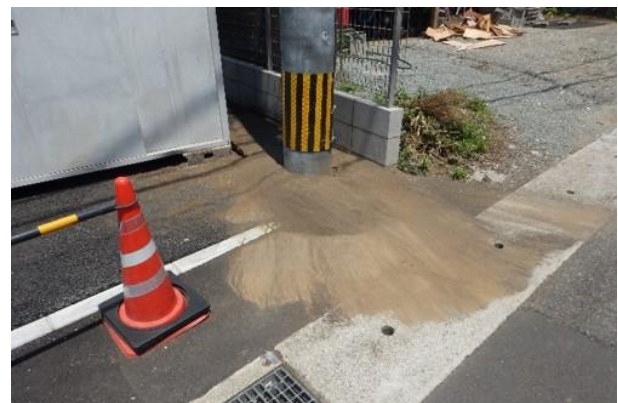
Photo 21: Traces of sand ejection adjacent to power pole in Kumamoto City (N 32.7583; E 130.6823)

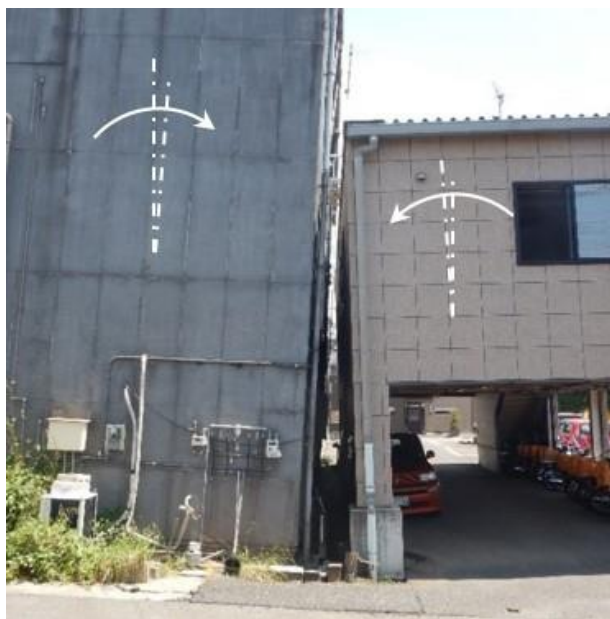
Photo 22: Liquefaction-induced tilting of two residential buildings in Kumamoto City (N 32.7600; E 130.6829)

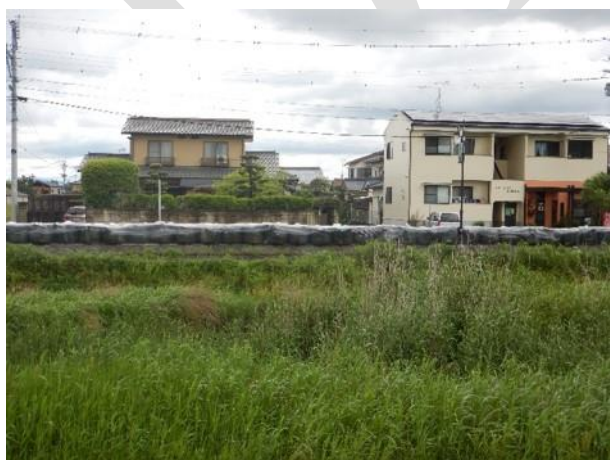
Photo 23: Temporary flood protection measure to mitigate the impact of liquefaction-induced subsidence of river bank in Mashiki Town (N 32.7832; E 130.8084)

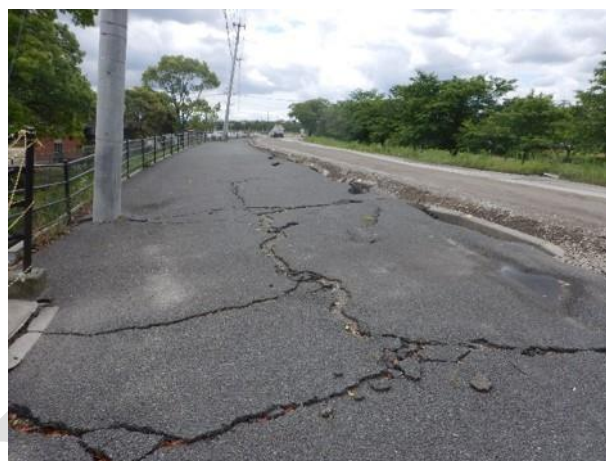
Photo 24: Cracking, lateral displacement and tilting of power lines induced by lateral spreading in Mashiki Town (N 32.7860; E 130.8177)

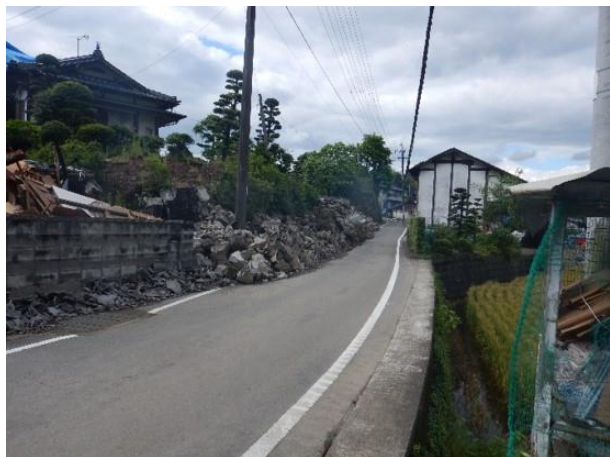
Photo 25: Collapse of a typical unreinforced wall in Nishihara Village (N 32.8056; E 130.8583).

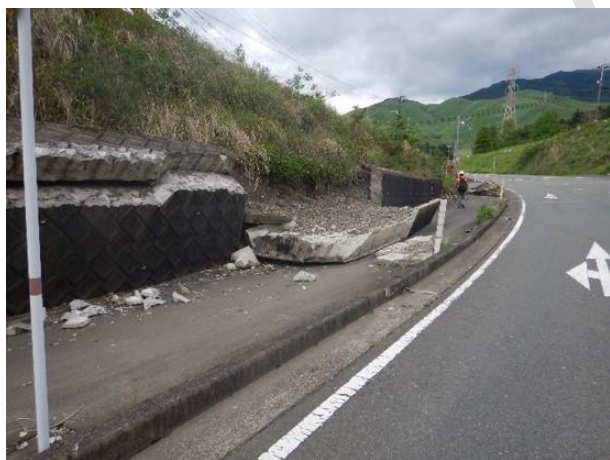
Photo 26: Fault rupture-induced collapse of a concrete facing unreinforced wall near the Ookirihata earth dam in Nishihara Village (N 32.8413; E 130.9317).

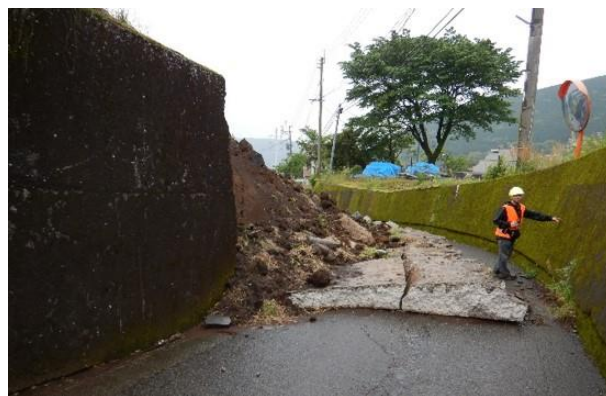
Photo 27: Complete collapse of a typical unreinforced concrete wall in Minami Aso Village (N 32.8844; E 130.9918).

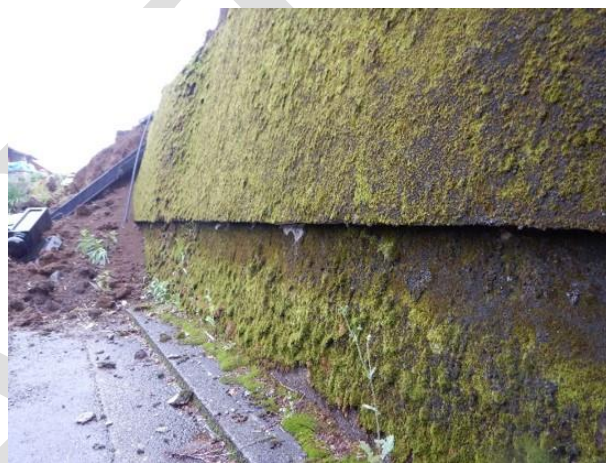
Photo 28: Displacement of the upper part of a wall along construction joint (N 32.8843; E 130.9916).

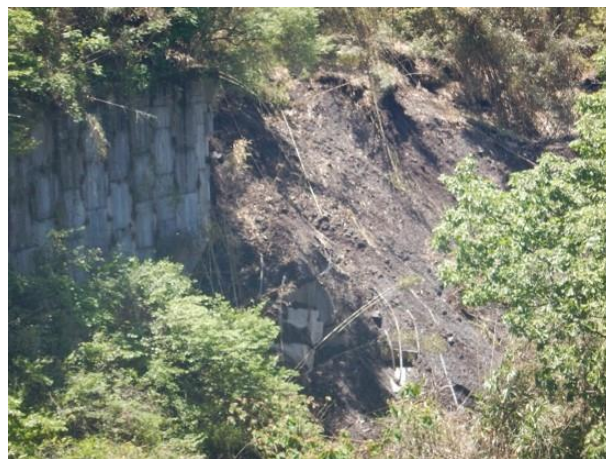
Photo 29: Total collapse of a reinforced earth wall near Tokyu Country Town (N 32.8805; E 131.0039).

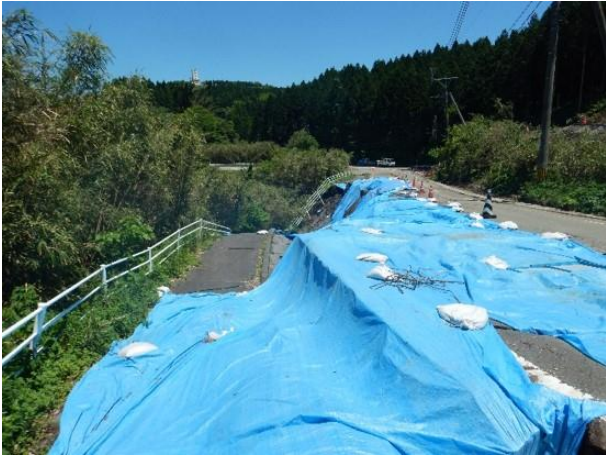
Photo 30: Effects of the collapse of the reinforced earth wall (shown in Figure 29) on the supported road (N 32.8804; E 131.0040).

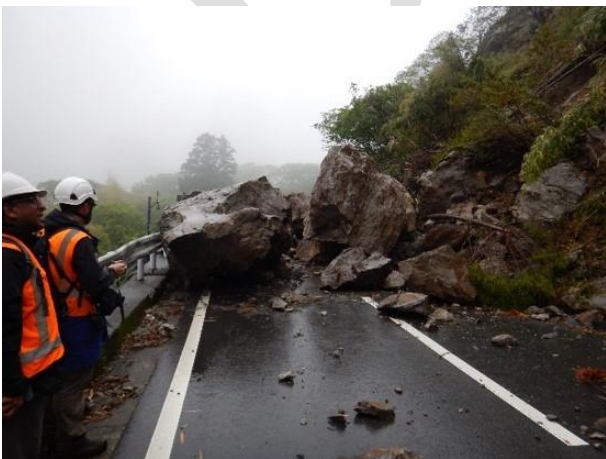
Photo 32: Road above the tied-back retaining wall (shown in Photo 31) closed by rock fall (N 32.8714; E 130.9924).

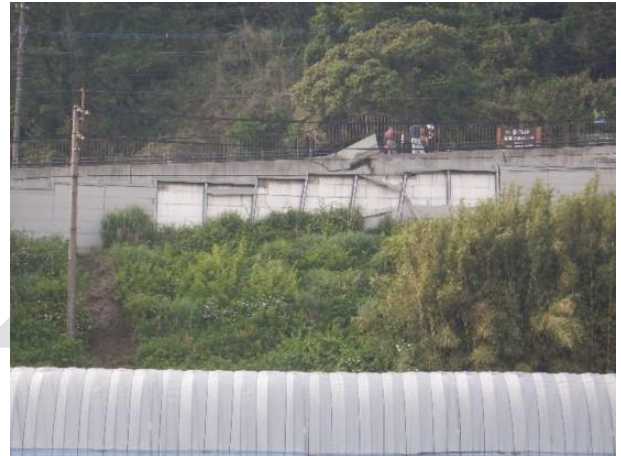
Photo 33: Good performance of a retaining wall with EPS block backfill (N 32.8792; E 130.9833).

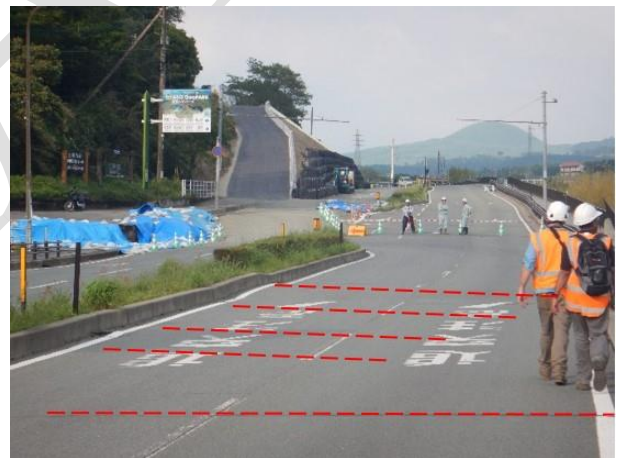
Photo 34: Some cracking appeared on the road supported by the walls shown in Photo 33 (N 32.8792; E 130.9833).

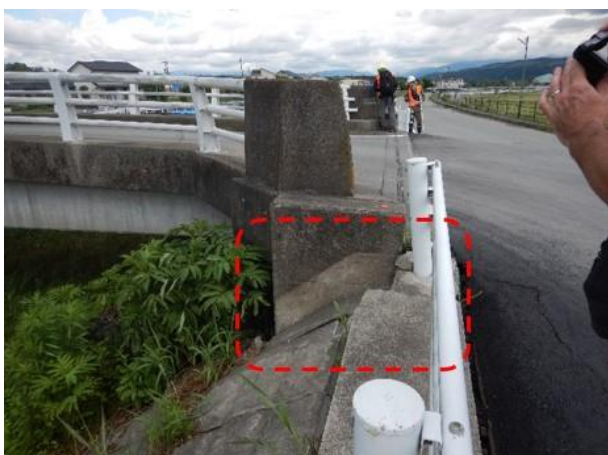
Photo 35: Typical settlement of short span concrete bridge approaches observed in Mashiki Town (N 32.7830; E 130.8085).

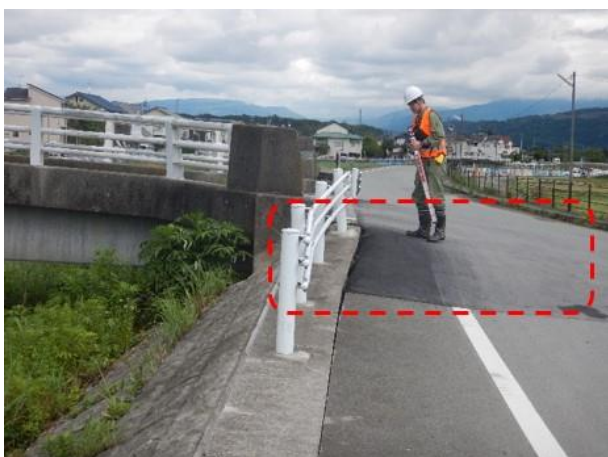
Photo 36: Temporary ramp being formed to provide access due to settlement of short span concrete bridge approaches (N 32.7830; E 130.8085).

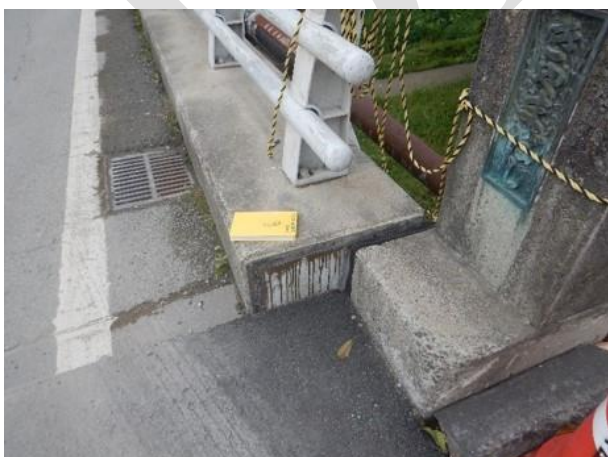
Photo 37: A two span bridge jumped 300 mm laterally off its bearings (view from the road) (N 32.7864; E 130.8186).

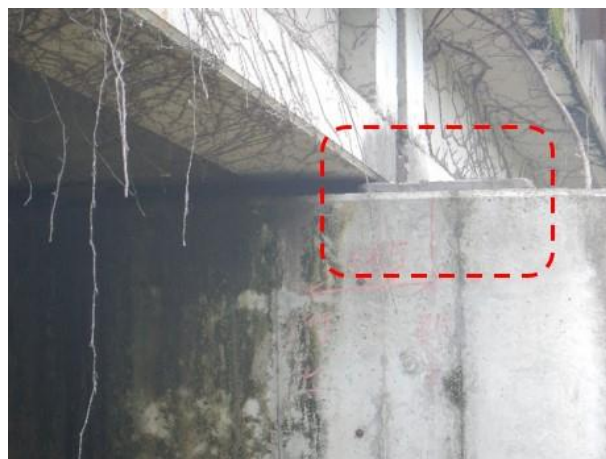
Photo 38: A two span bridge jumped 300 mm laterally off its bearings (view of the bearing) (N 32.7864; E 130.8186)

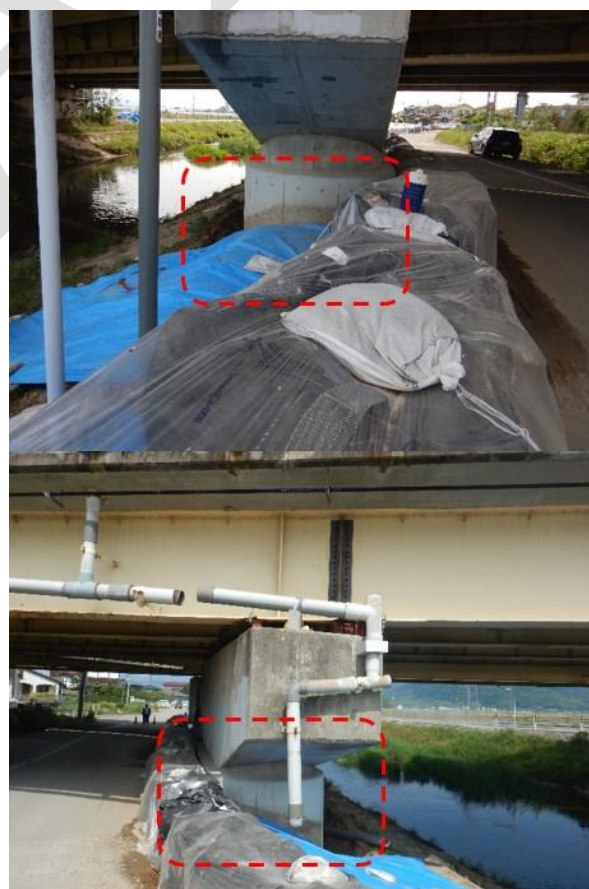
Photo 39: Ground settlement around piers of a long span steel girder bridge observed in Mashiki town (N 32.7787; E 130.79.39).

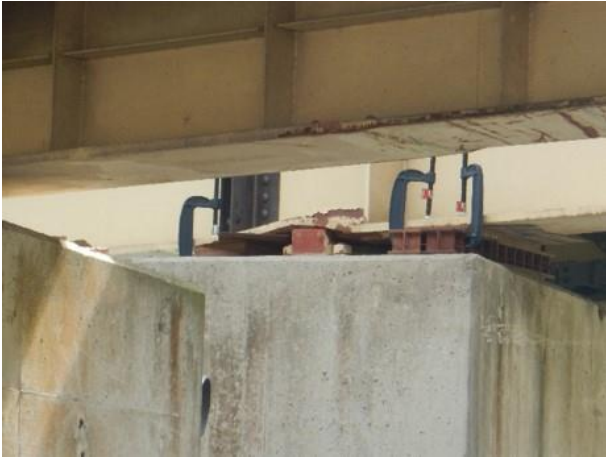
Photo 40: Local buckling of girder bottom. The girders were re-levelled temporarily with steel plates either side of original bearings (N 32.7790; E 130.7939).

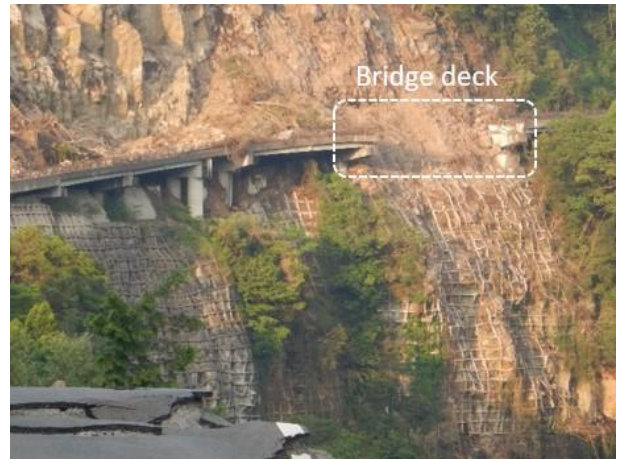
Photo 43: Landslides caused also the collapse of bridge decks in the mountainous areas of Mt. Aso volcanic caldera (N 32.8752; E 131.9886). See also Photo 17.

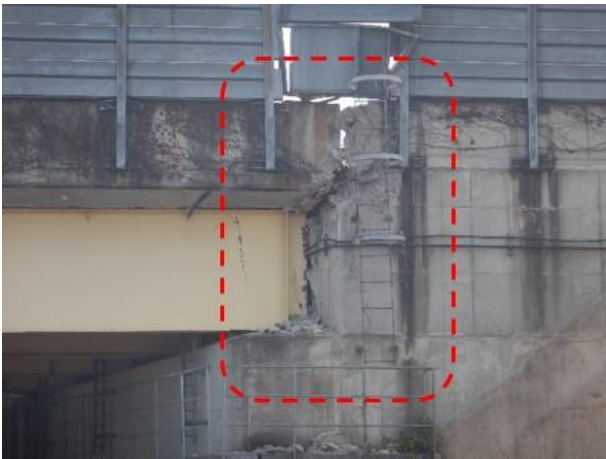
Photo 41: Punching of I-shape girder ends into the abutment wall caused shearing of back wall (N 32.7789; E 130.7943).

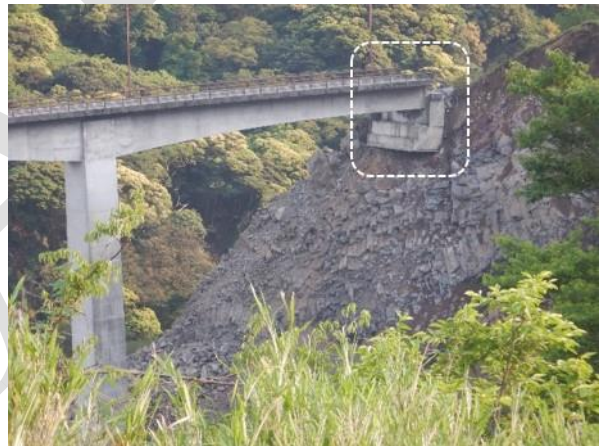
Photo 44: Abutment foundation failure due to the collapse of underlain columnar jointed bedrock (N 32.8770; E 130.9840). See also Photo 18.

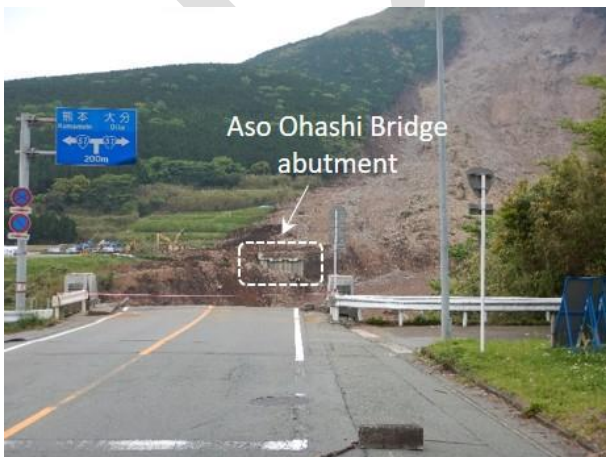
Photo 42: Landslides caused the collapse of a number of bridges in the mountainous areas of Mt. Aso volcanic caldera (N 32.8834; E 130.9896).

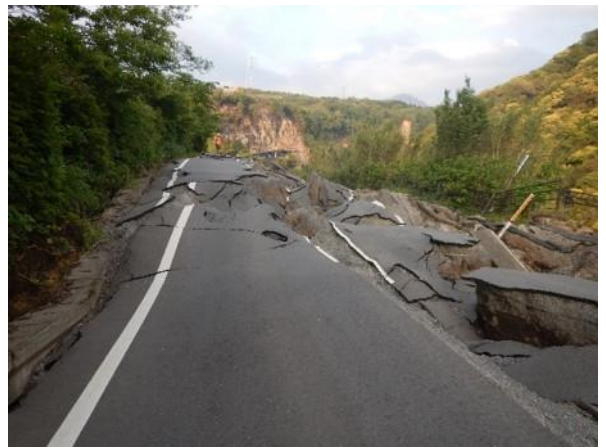
Photo 45: Severe disruption to approach embankment due to the collapse of underlain columnar jointed bedrock (N 32.8744; E 130.9827). See also Photo 18.

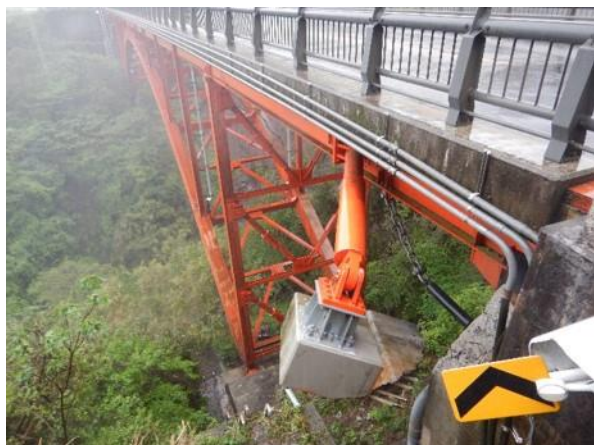
Photo 46: Connection of a retrofitted damper of steel arch bridge failed at one abutment (N 32.8779; E 130.9094).

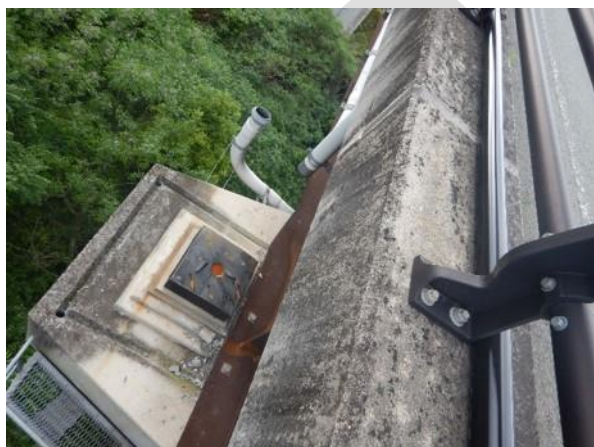
Photo 47: A curved steel arch bridge jumped laterally off bearings (N 32.8426; E 130.9272).

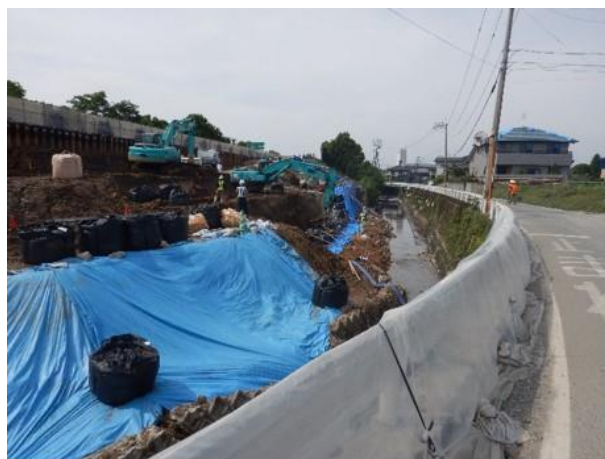
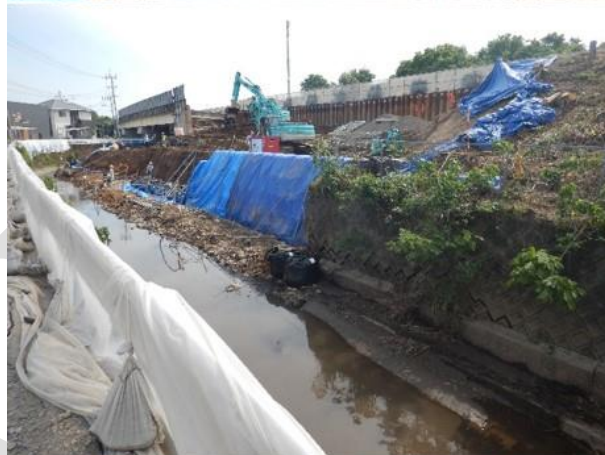
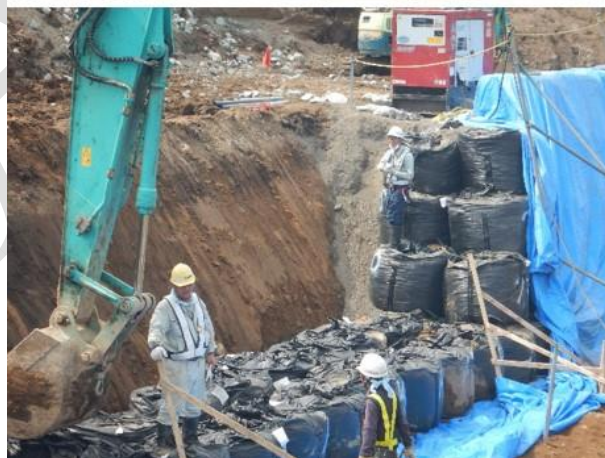
Photo 48: Collapse of a retaining wall supporting an expressway embankment. Gravel filled polyester bags were used to quickly rebuild the wall and reopen the expressway (N 32.7792; E 130.7943).

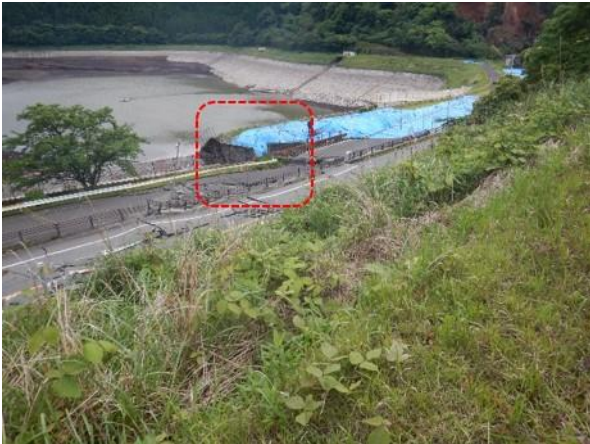
Photo 50: Fault rupture damaged the spillway of the Ookirihata earth dam (N 32.8414; E 130.9317). See also Photo 4.

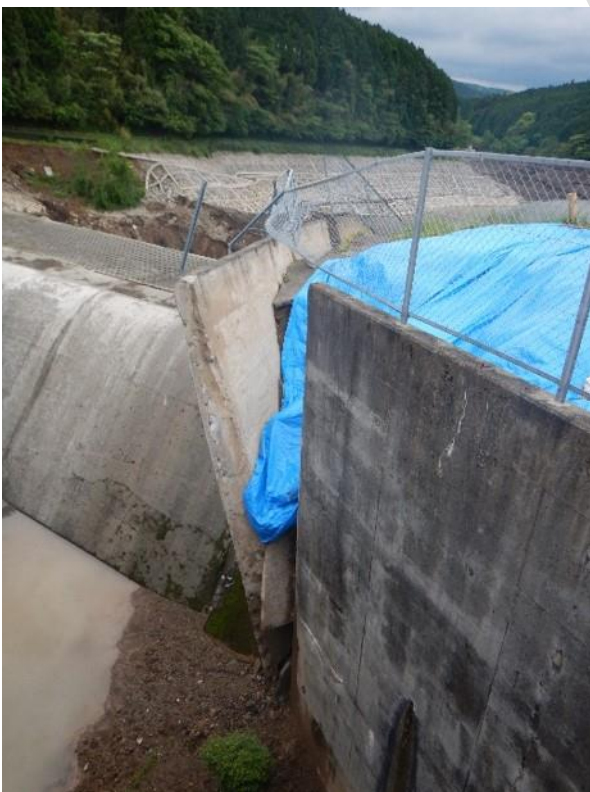
Photo 51: Close up of the damaged spillway of the Ookirihata earth dam (N 32.8414; E 130.9317).

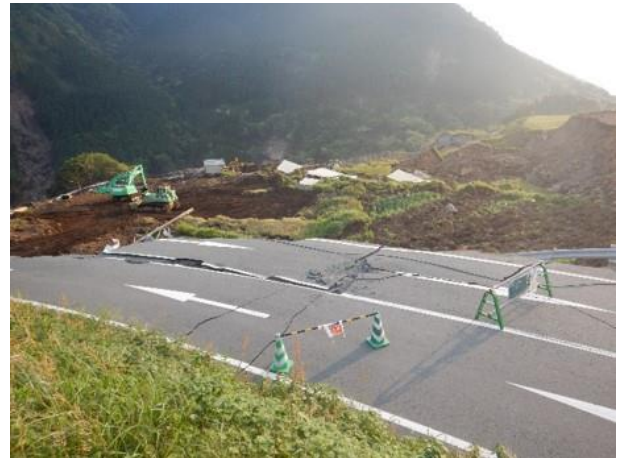
Photo 52: New dam construction site destroyed by fault rupture (N 32.8776; E 130.9764). See also Figure 20.
